Mejaro Inspection Services

Inspection Report

One Happy Lane
Happyville, USA

Inspection Date August 17, 2017
Client Perfect Client

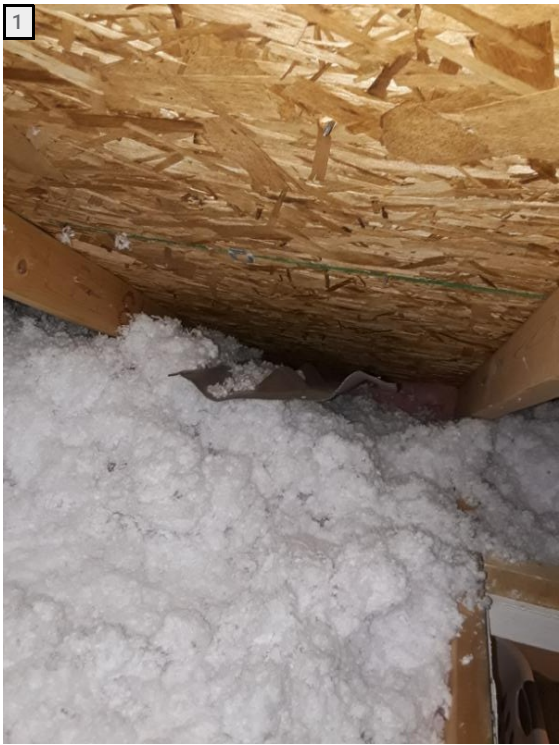
Baffles at the rafters. Excellent addition which will help keep the attic space and roof deck healthy.

Location Attic

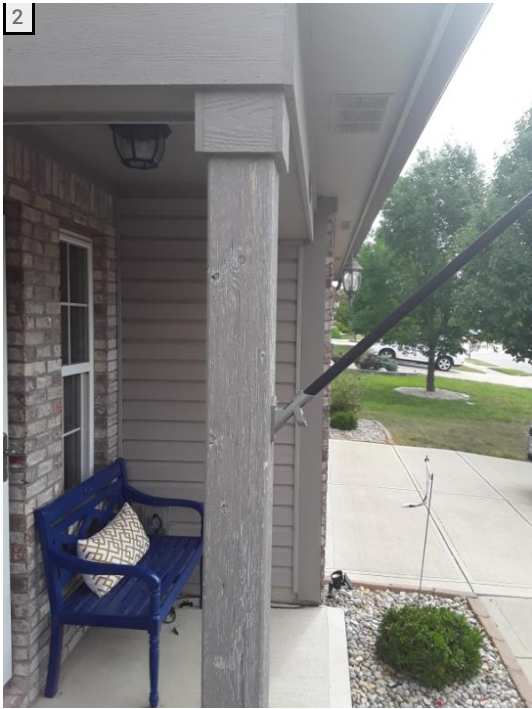
C.1.a. Balcony, Deck or Porch(Exterior: Ground View): Stain, paint or sealer has peeled, faded or bleached out

Stain, paint or sealer has peeled, faded or bleached out

Location	Exterior: Ground View
Impact	Without sealer, the wood is not protected from the elements
Suggested Action	Restain and/or reseal with a weather resistant sealer

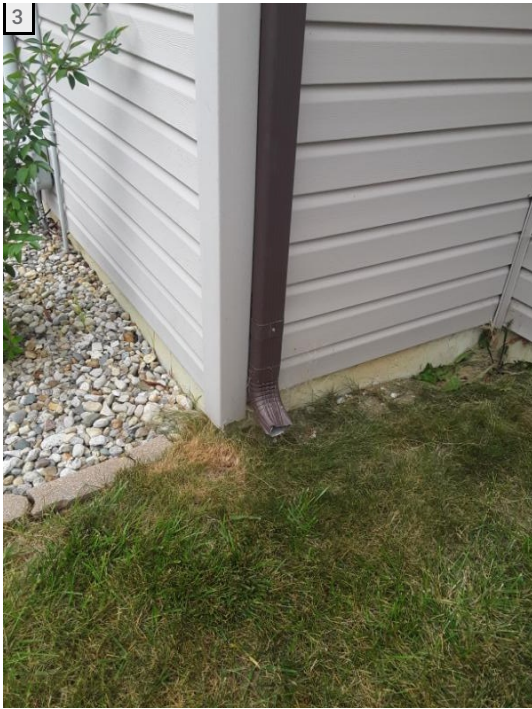
D.1.a. Downspout(Exterior: Ground View): Extensions are missing

Extensions are missing

Location	Exterior: Ground View
Impact	Water flow is not contained and may drain near foundation increasing the risk of flooding
Suggested Action	Install downspout extensions reaching 5-6 feet from the building

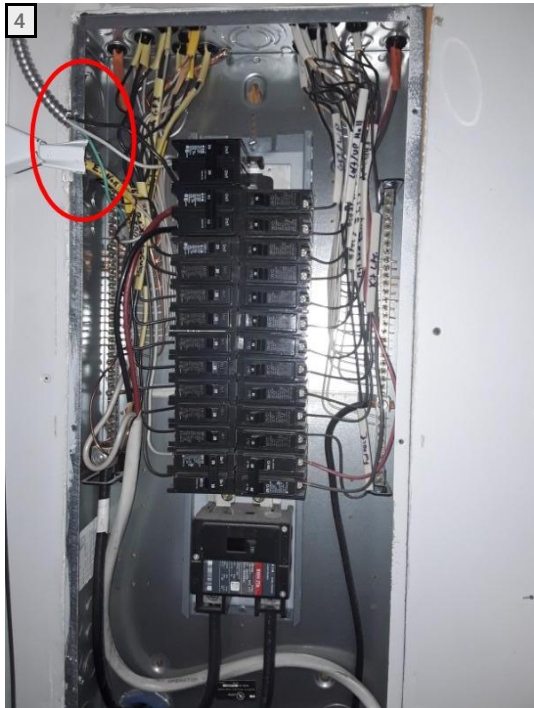
F.3.a. Electric Service Panel(Attached Garage): Amateur wiring

Amateur wiring

Location Attached Garage

Impact The amateur wiring renders the electrical supply unsafe. The wiring should use the box knockouts. As it currently sits, this is not a legal termination.

Suggested Action Have repaired by a licensed electrician

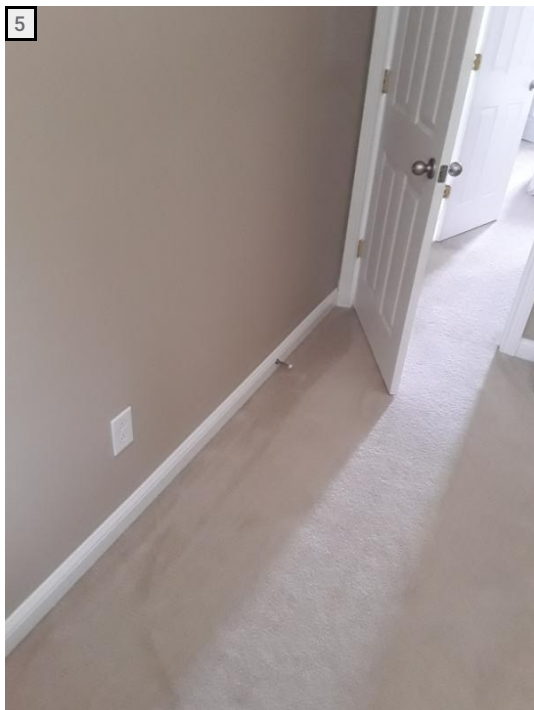
F.8.a. Outlet(2nd Bedroom): No power

No power

Location	2nd Bedroom
Impact	Power is not supplied to this outlet
Suggested Action	Have evaluated by a licensed electrician

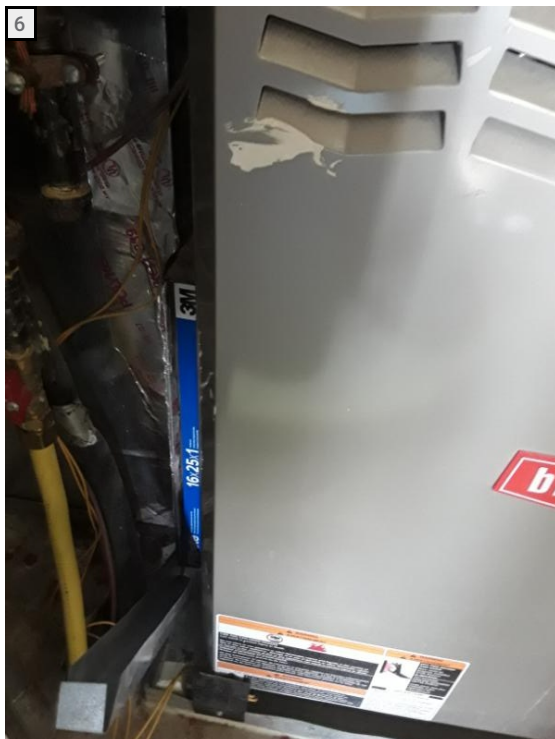
Filter location - replace every three to six months. Also recommend having the unit serviced once a year.

Location Utility Room

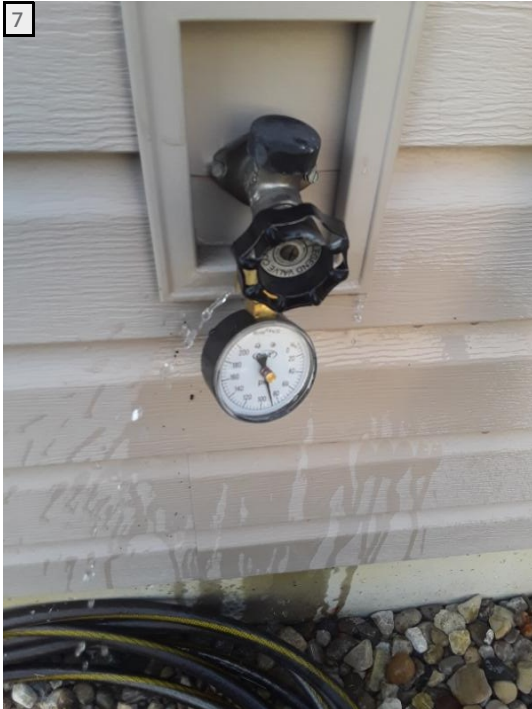
Water pressure nearing high levels

Location Exterior: Ground View

Impact The most common effect of high pressure is leaks in your plumbing system. They may be tiny pinhole leaks, and may only come at intermittent times. Even a small leak can lead to much bigger problems if it occurs in a spot where it can damage your walls or floor.

Suggested Action If pressure exceeds 85PSI, contact a professional and licensed plumber to install a pressure regulator on your main water line.

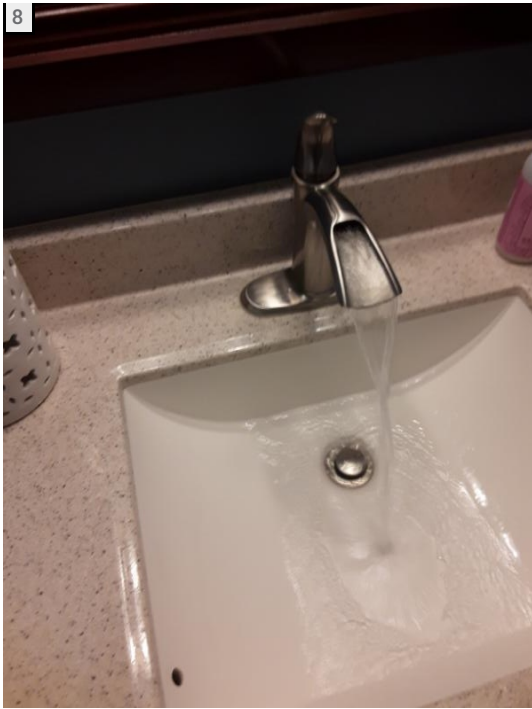
Drain stop is not connected to the drain

Location Partial Bathroom

Impact Without a functioning drain stop, you will have to manually install and remove the drain stop to fill and drain the sink

Suggested Action Repair the drain stop

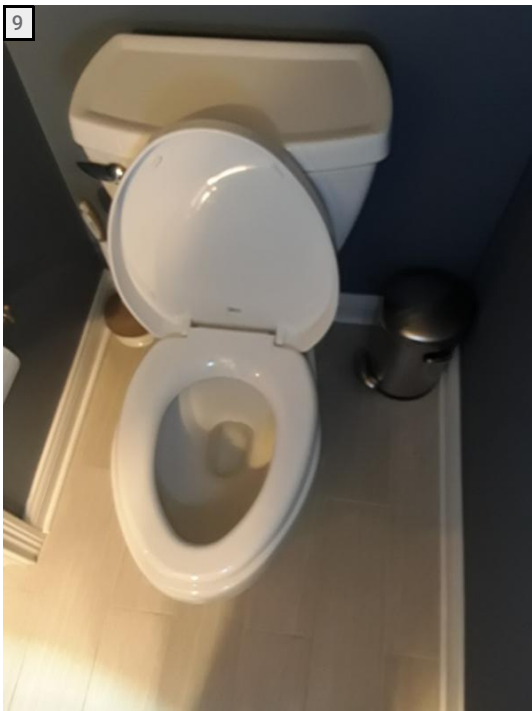
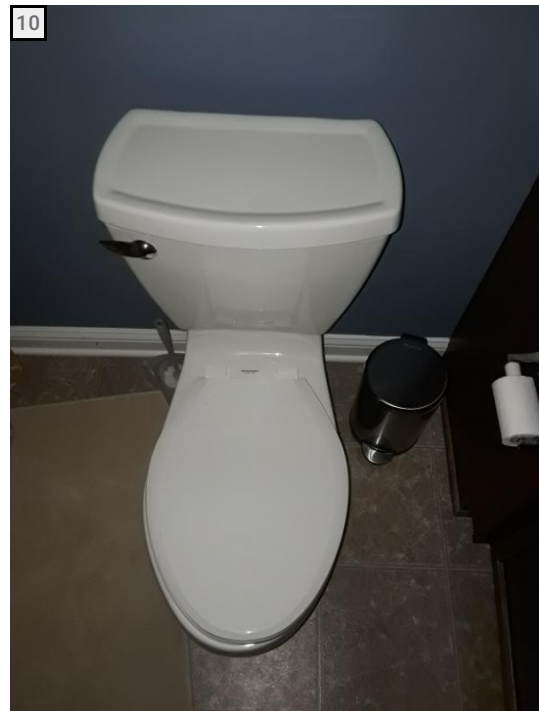
Loose

Location	Partial Bathroom, 2nd Bathroom
Impact	A loose toilet may damage the wax ring that prevents leaking
Suggested Action	Try securing the toilet. If unable to then remove and reinstall the toilet, including replacing the wax ring

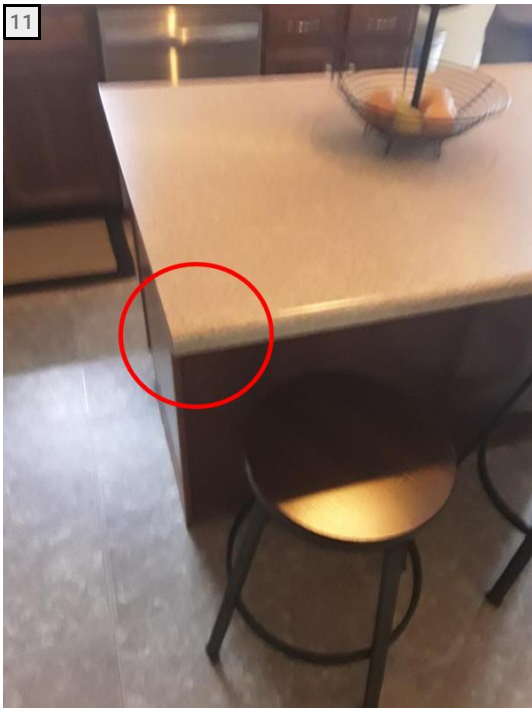
Not secured properly

Location	Kitchen
Impact	The countertop may shift during use
Suggested Action	Secure the countertop to the cabinet frame

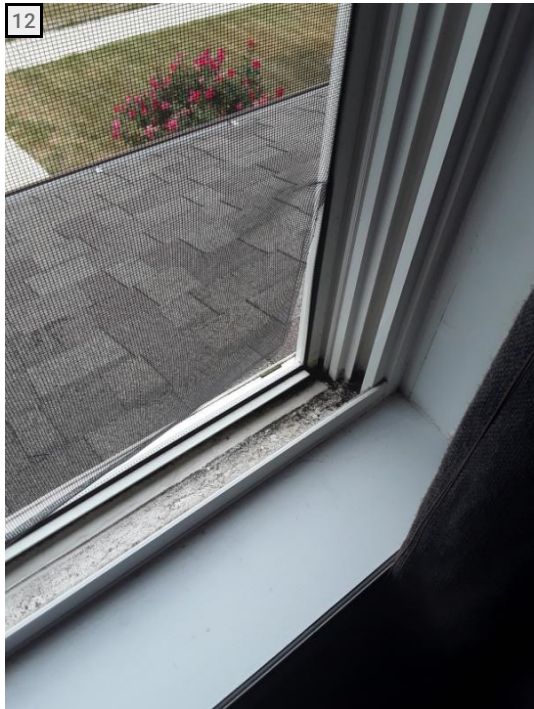
Torn or damaged

Location	1st Bedroom
Impact	Should the window be open, lacks protection from insects
Suggested Action	Repair or replace the screen

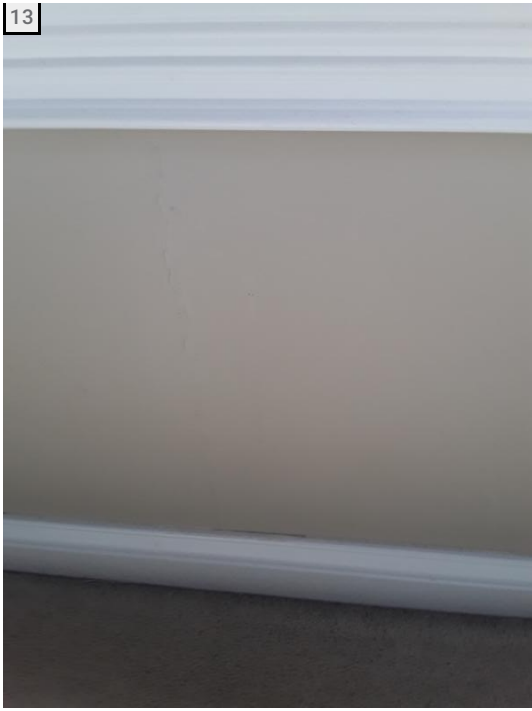
- L.16.a. Wall(1st Bedroom): Drywall has settling cracks

Drywall has settling cracks

Location	1st Bedroom
Suggested Action	Repair with drywall tape and drywall compound if needed otherwise just repaint
